# AFIP-6 MKII First Cycle Report

March 2012

Idaho National Laboratory Idaho Falls, Idaho 83415

INL/EXT-25-25170

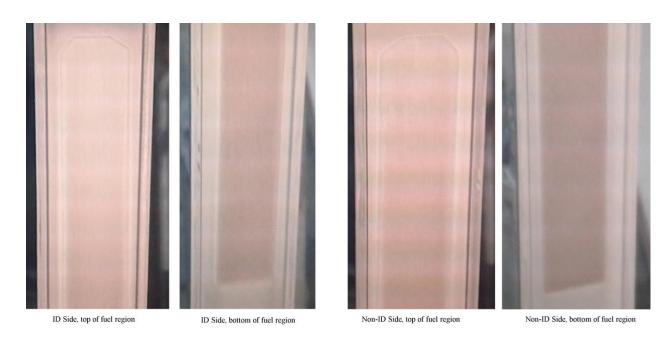
The retriever, ramrod, ram, and frame assembly 6II-1 were removed without event. No unexpected phenomena were observed in the fuel region of the 6II-1 fuel plate frame assembly. The fuel region exhibited oxidation whose coloration was consistent throughout and showed no evidence of spallation or blistering as seen on the original AFIP-6 fuel plates. This is seen in Figure 7. (Note that the horizontal banding seen in some figures is a product of the image rendering process and is not present on the fuel plate). The integrity of the fuel region was further verified on March 13<sup>th</sup>, 2012 by ultrasonic characterization with the in-canal flat plate scanner as seen in Figure 8.

Figure 7: 6II-1 Fuel Regions Post 151A

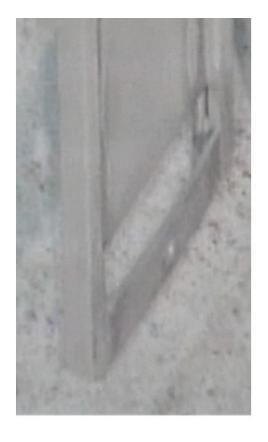
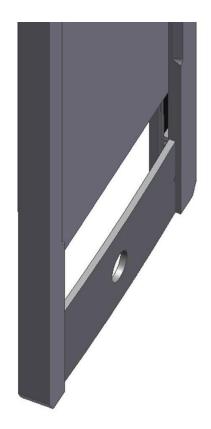
Immediately following removal from the irradiation assembly the bottom plate component of the 6II-1 frame assembly was observed to be present in its intended axial location within the frame assembly. However, it was also observed that the bottom plate exhibited some slight deformation (bowing) and was precariously held between the flats of the frame rails as seen in Figure 9. Note that the bottom plate has shifted out of the plane of the rail-grooves/fuel-plate. The underwater canal footage demonstrated that the bottom plate was visible in this state until the camera panned up so that the bottom plate was out of the field of view. After the whole frame assembly swung slightly to the side and tapped the retriever assembly (which was lying on the working tray) the camera panned down and the bottom plate was no longer between the rails. The bottom plate was found lying on the working tray. Assumedly this small impact dislodged the item. The manner of handling did not appear to be rough or negligent. The fuel plate frame was placed in approved storage and plans to UT scan the plate were suspended. The state of the 6II-1 frame following this event can be seen in Figure 10.

Non-ID Side, bottom of frame (canal footage)

Non-ID Side, bottom of frame (CAD rendering)

Figure 9: Frame 6II-1 Immediately Following Removal from Irradiation Assembly

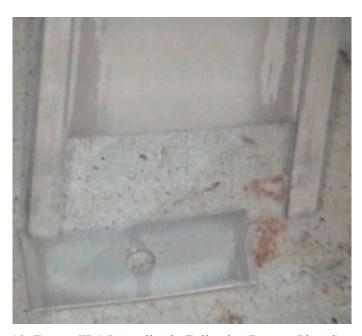
Figure 10: Frame 6II-1 Immediately Following Bottom Plate Separation

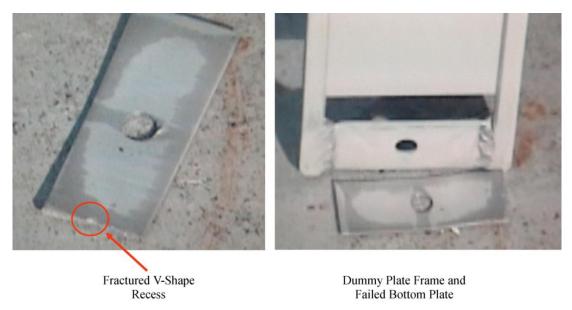
The separated bottom plate was also further examined from multiple camera angles. This gave visual evidence of fracture surfaces on both short edges of the bottom plate. One edge exhibited a small "V-shaped" recess near the center of the short edge. The dummy frame assembly was positioned near the separated bottom plate to give a reference for dimensional scale. This showed that the width of the remaining bottom plate was equivalent to the distance between the inner rail edges of the frame assembly. This suggested that the bottom plate had fractured on both sides near the swage joints. See Figure 11.

Figure 11: Fractured Edge of Failed Bottom Plate

The fractures which occurred on both of the short sides of the bottom plate, along with the remnants which remained captive under the rail, demonstrated that the bottom plate fractured at or very near to the swage joint. This was likely due to the stress concentrator and local deformation on the plate surface caused by swaging. While other loading modes were hypothesized, (e.g. differential channel to channel pressures and/or thermal expansion gradients), the most likely failure mode was determined to have been flow induced vibrations and resonance with the bottom plate; giving way to amplification and fracture [36]. Note that an increase in flow velocity was the principal design change for AFIP-6 MKII. The AFIP-6 MKII fuel plate channel flow rate was calculated to be 18.2 m/s and represented a significant increase from 10.4 m/s for the original AFIP-6 [4].

In the supplemental analysis [36], a calculation of the bottom plate natural frequencies showed that mode no. 2 was a close match to the frequencies of vortex shedding for normal conditions 2 pump (within 10%) and 3 pump (within 3%) flows. Also, mode no. 2 was shown to be a twisting motion (from top-to-bottom, see Figure 17) that would increase the incident angle of the bottom plate to the flow. The frequency matches of the bottom plate and coolant vortex shedding, with the compounding twisting mode no. 2, were shown to make adverse resonance conditions likely. Therefore, damaging vibrations of the bottom plate were predicted to occur under normal operations. Damage was predicted to be due to high stresses with a resulting reduced fatigue life. Failure under this scenario was expected to have progressed as follows: 1) further work hardening along the clamped edges; 2) fatigue cracking at the front and rear of the clamped edges; 3) progression aft and forward (respectively) until the material holding the piece in place was limited to a small band of material at the axis of rotation; 4) failure in shear. The V-shaped features of Figure 11 and Figure 12 are consistent with this progression. The swage joint likely compounded the issue by creating a stress concentration on the bottom plate clamped edges where the stresses would be largest under mode no. 2 resonant vibration.

The root cause of this incident was an unexpected phenomena and merits further investigation in order to better understand it and preclude future occurrences. Consequently, it is recommended that the separated bottom plate be retrieved from the ATR canal and be shipped to the Hot Fuel Examination Facility (HFEF) for further evaluation of fracture surfaces (e.g. more resolved optical evaluation). This should be accomplished in concert with one of the upcoming RERTR post irradiation shipments.

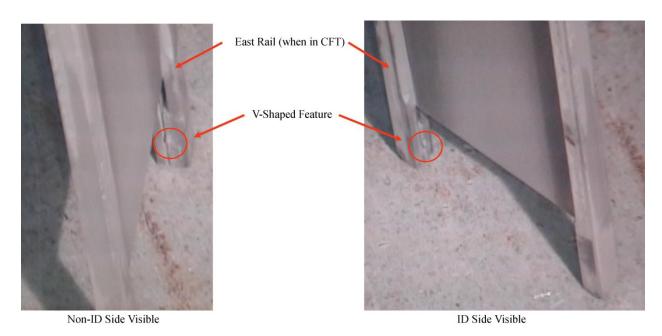
The fuel plate frame assembly 6II-1 was further examined on February 28<sup>th</sup>, 2012. This showed that the remnants of the edges of the separated bottom plate were captive within the groove of the rails; suggesting that the swage joints are intact. The inverse of the fractured V-shape seen in Figure 11 was also observed on one of the bottom plate edge remnants. These can be seen in Figure 12 and Figure 13.

Figure 12: Bottom Plate Edge Remnants in "East" Rail Groove

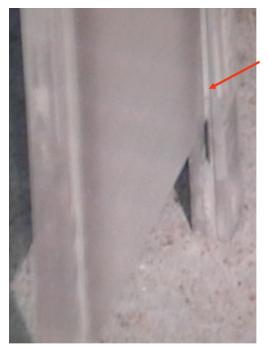
West Rail (when in CFT)

Figure 13: Bottom Plate Edge Remnants in "West" Rail Groove
